ARCHITECT'S FIELD REPORT

Project Name:	Weslin Community School #3 New High School, Trenton, Ill.	<input type="checkbox"/> Owner:	Weslin CUSD #3
Project Number:	09-1053.03	<input checked="" type="checkbox"/> Architect:	FGM Architects
Date:	July 17, 2013	<input type="checkbox"/> Consultant:	ASDG, BRiC, Neikirk Holland
Time:	10:00 am	<input type="checkbox"/> Field:	Holland
Weather:	Sunny	<input type="checkbox"/> CM:	Holland Const.
Temperature:	Low 90's	<input type="checkbox"/> Other:

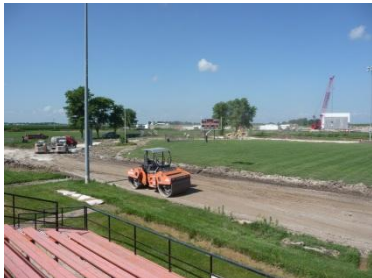
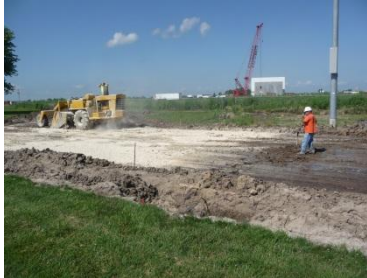
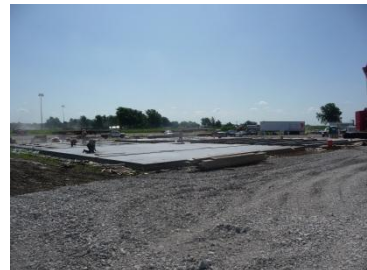
Site - General

- Site grading continues on athletic track.
- Lime stabilization has started on athletic track.
- Contractor coordination meeting held on site.
- Temporary casting slabs still being used to form tilt-up panels.

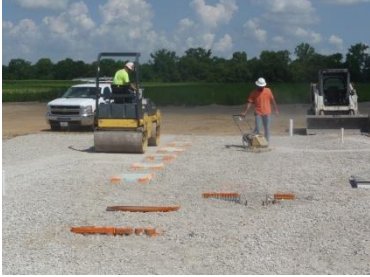
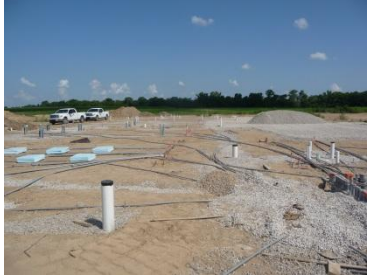
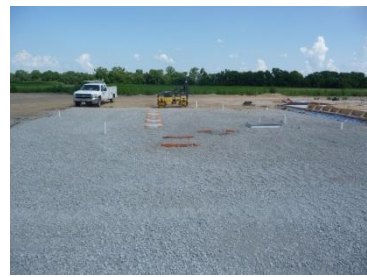
Building Area "A" (North Classroom Wing / Kitchen)

- Footings and foundations appear complete.
- Underslab plumbing and electrical work continues.
- Rock being placed for concrete slab sub-base.
- Rock compaction being done in Family Consumer Science – A146 area
- Concrete slab pour for this area is scheduled for next week.

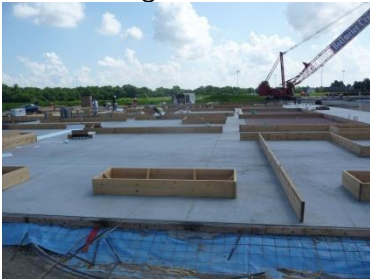
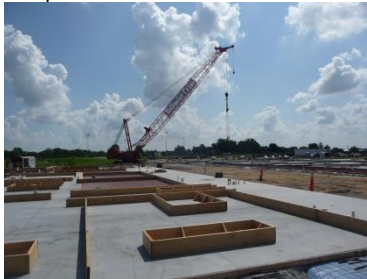
Building Area "B" (Shops and Locker Rooms)

- Concrete slab on grade have been poured. Slab now being used as a casting slab for tilt-up panels.
- Tilt-up panels being formed. Brick inlay being placed. Mechanical / Electrical rough in started on some panels.

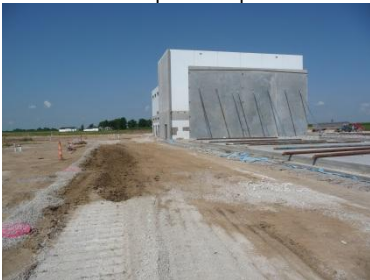
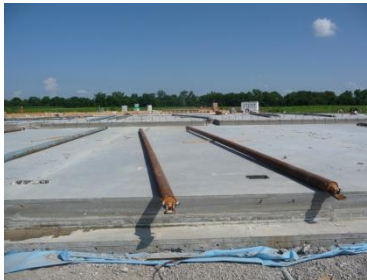
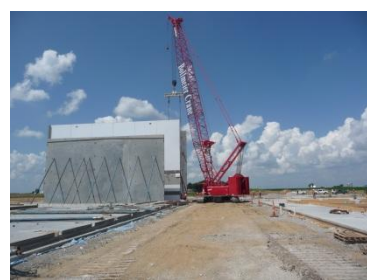
Building Area "C" (Gym, Band/Vocal, District Office)

- Tilt-up walls panels have been erected on west side of gym.
- Tilt-up wall panels for north and south walls scheduled for next week.

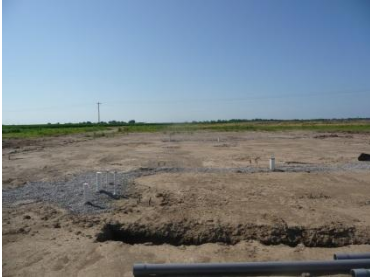
Building Area "D" (South Classroom Wing / Administration)

- Underslab plumbing and electrical work continues.
- No additional work appears to be done in this area since last report.

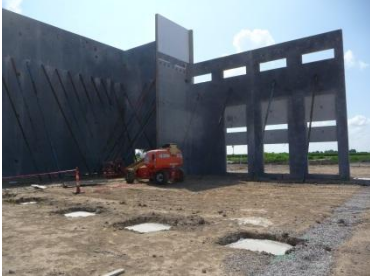
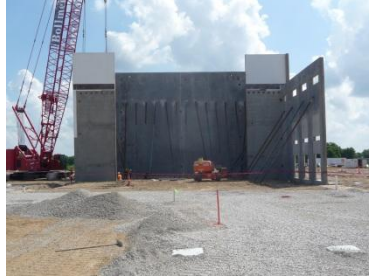
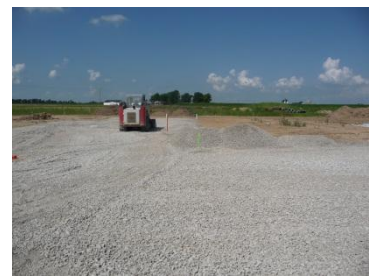
Building Area "E" (Media Center, Cafetorium)

- Underslab plumbing and electrical work continues.
- Rock being placed for concrete slab sub-base in Media Center E109 area.
- Tilt-up panels being erected on south, east, and west walls at the Stage.
- Tilt-up panels being erected on south side of cafetorium.

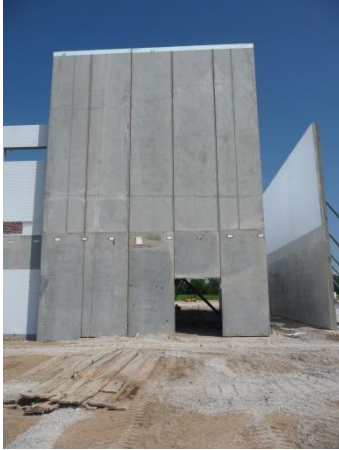
- The two end panels at the south side of the Stage have additional joints from what is shown on the construction documents. After follow up discussion with Holland, the tilt-up contractor (Fenix) engineering department needed these joint due to the starting and stopping of the wall insulation. These joints will be filled and will not be noticeable after the panels are painted.

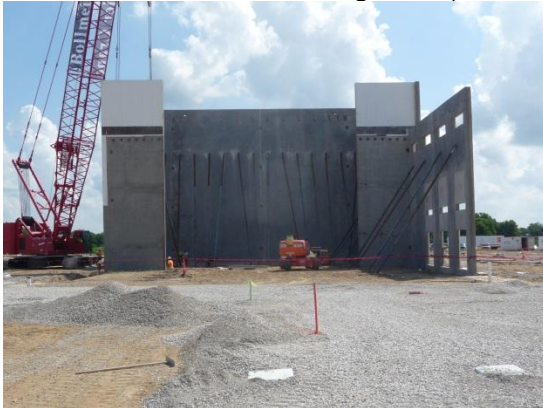
- The tilt-up panels on the west side of the Stage shown in the photo below was designed to have brick full height of the panel. After follow up discussion with Holland, the tilt-up contractor (Fenix) agreed the brick was omitted. Contractor looking into options to post apply the brick.
